## Servicing the clutch on Older CPTs

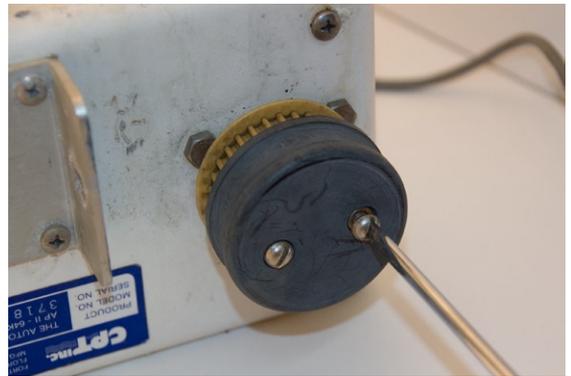
1. Remove clutch: Make sure the ends of the two sheer-pin screws are not bent, then remove the two screws from the back of the clutch. Remove the circlip, then remove the drive gear from the driveplate shaft.

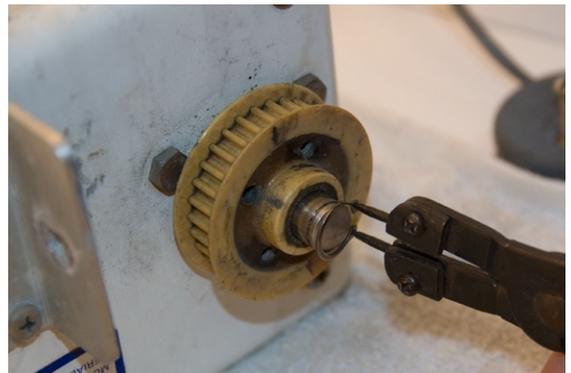
2. Remove drive plate/shaft:

If you have an older CPT, there is a hole in the shaft; insert a narrow screw-driver and unscrew the shaft from the motor shaft (it has normal threads). Gently pry the circular plate off the knurled motor shaft; gently pry all around the plate, force is not needed. Avoid prying against the aluminum box—use one of the bolt heads instead (as shown in the photo). Do not remove or lose the black-rubber watertight seal found under the plate.

(Clean & Lube Clutch & O-Ring before re-assembly)

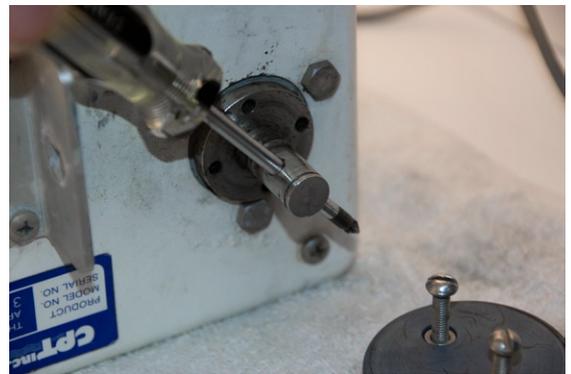
3. Clean the drive plate, shaft, and hub of the clutch gear. Oil or grease the parts before re-assembly. Be sure to work some oil into the détente ball that protrudes into the hub of the clutch gear.

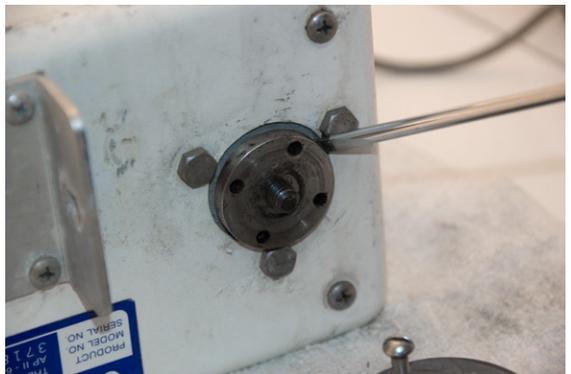
4. Sometimes if a shear pin breaks, the tip can become stuck behind the driveplate of the clutch. The trapped tip will make a scraping and screeching sound when the motor turns. Remove the drive plate and remove the tip of the pin to remedy the problem.
