Mounting Tip: Do not use a long carriage bolt with the drive box.

Mounting Tip: Old CPTs that have trouble with tilting drive boxes

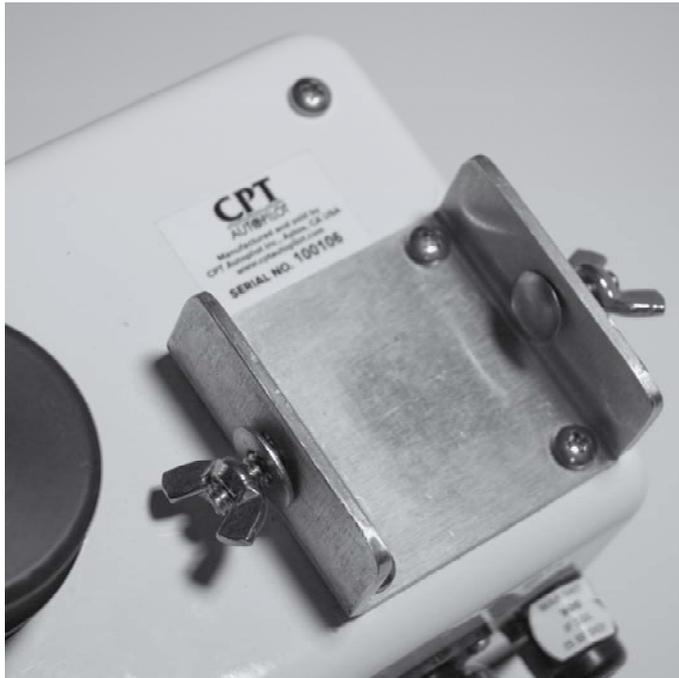
Problem: In the 1990's it was popular to mount the CPT drive box using a plastic T-handle with a long carriage bolt. It has come to our attention that the long carriage bolt is not designed for use with the mounting bracket. The mounting bracket uses a square hole, and was not designed for a round bolt. No matter how hard you tighten the long carriage bolt, it will not tighten the mounting bracket properly.

After several seasons the long carriage bolt will cause wear in the square mounting bracket hole. If your bracket hole is worn the drive box will begin to tilt and have trouble aligning vertically with the steering wheel. This will eventually cause excessive clutch wear.

Solution: Replace the long carriage bolt with two short carriage bolts, $\frac{1}{4}$ " x $\frac{3}{4}$ " length, which are designed for the bracket and will help with alignment. We will replace these bolts at no charge when servicing your pilot, or please feel free to contact us.

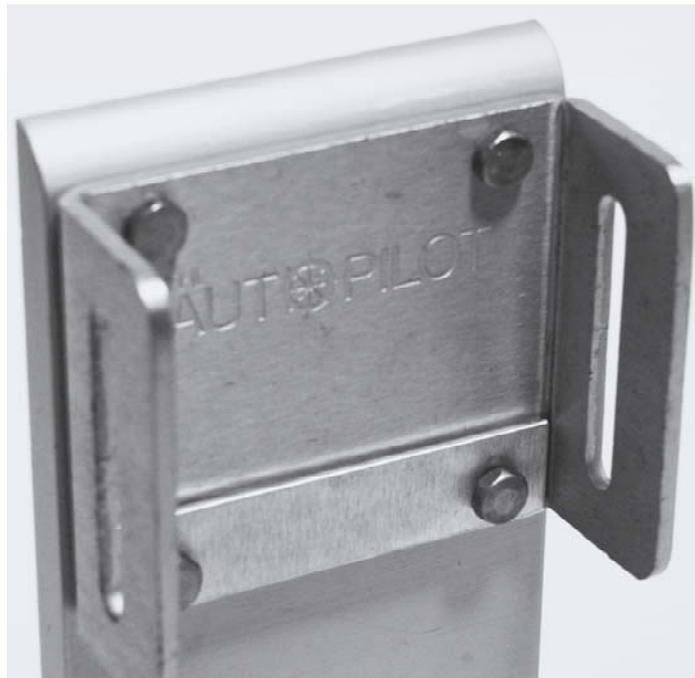
Problem: On an older unit that has seen decades of use you may have developed belt alignment issues if the rear edges of your bracket are worn. This will cause the drive box to tilt and not align properly with the belt; sometimes the clutch will disengage on its own because of the belt angle.

Solution: An easy fix is to add a shim to the bottom bolts of the bracket mounted to the pedestal or bulkhead. This will bring the bracket back into alignment. Let us know when we service your pilot and we'll provide this shim at no charge, or feel free to contact us.
